A CULTURAL RESOURCE SURVEY AT ORWELL RESERVOIR OTTER  
TAIL COUNTY MINNESOTA (U) IMPACT SERVICES INC MANKATO MN  
R A STRACHAN ET AL. JUL 86 DACW37-85-M-1841

# AT ORWELL RESERVOIR, OTTER TAIL COUNTY, MINNESOTA

DEPARTMENT OF THE ARMY  
ST. PAUL DISTRICT, CORPS OF ENGINEERS  
REQUEST NO. DACW37-85-M-1841

July, 1986

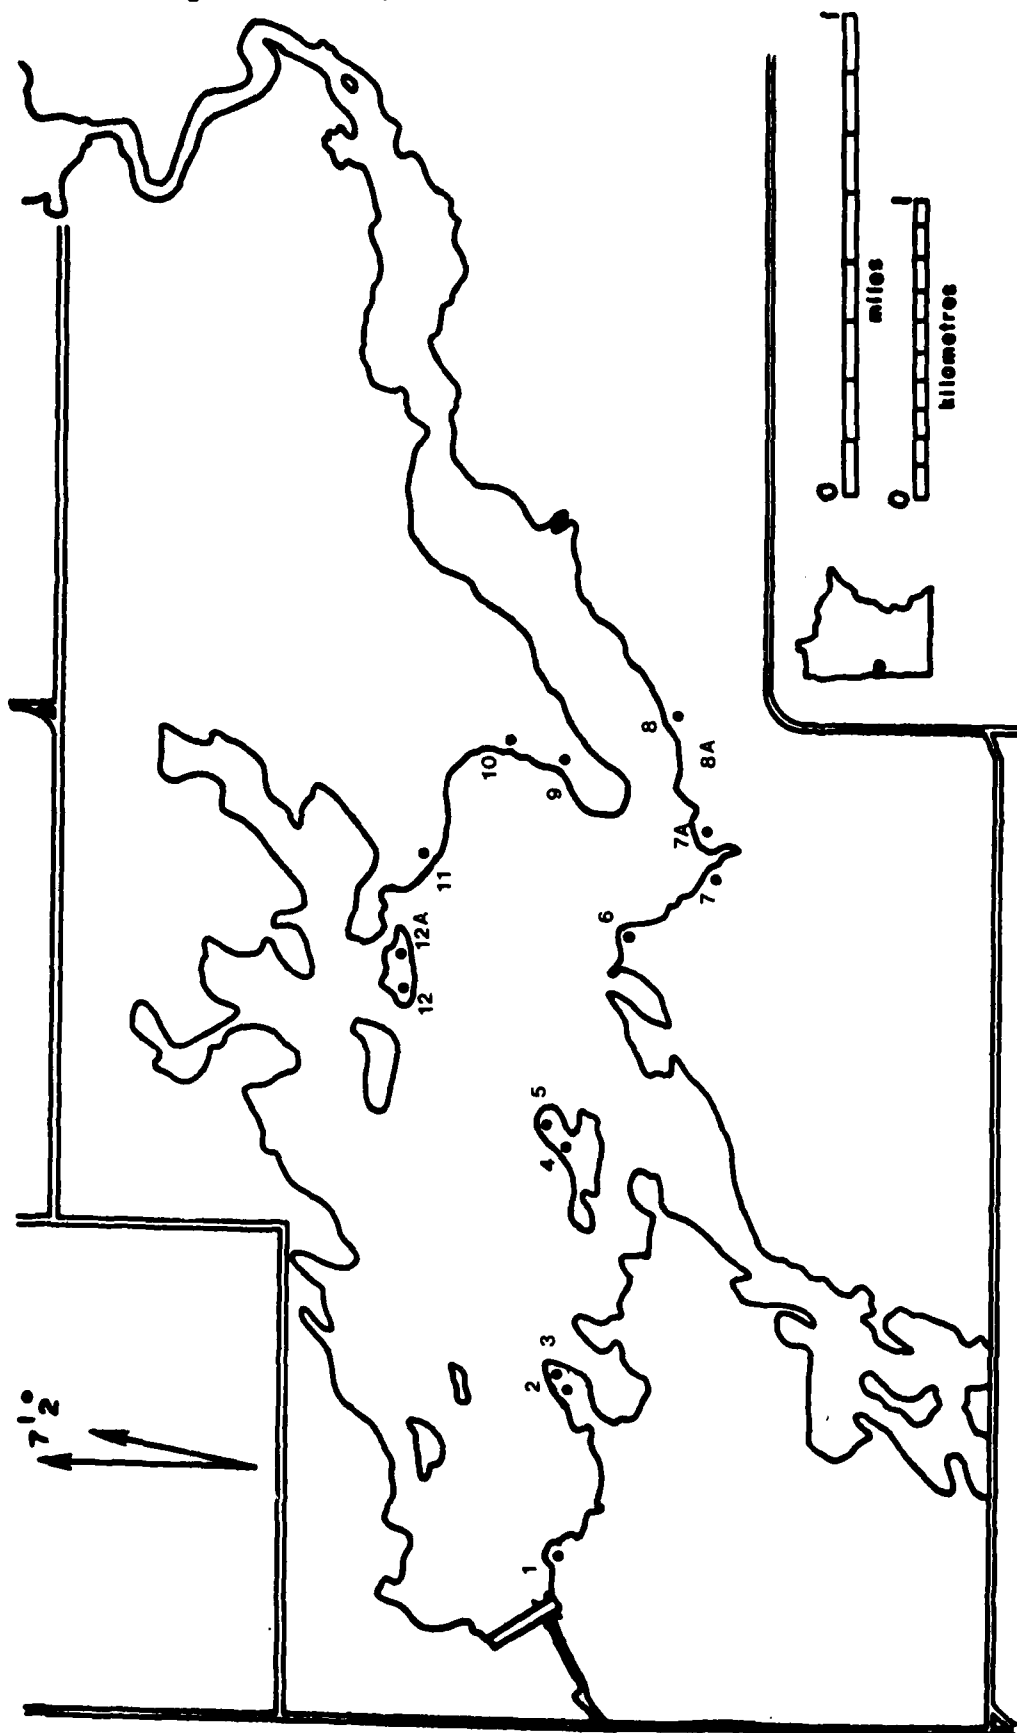
Figure 2: Map of Orwell Lake with Erosion Stations

The specific areas to be surveyed under this contract were initially the focus of a shoreline erosion study done by Reid (1983). His project objective was to identify and quantify the various types of erosional processes that have a negative impact on the shoreline at Orwell Reservoir. These specific survey locations (called Erosion Stations by Reid) are located in Figure 2 and on a U.S.G.S. topographic map on Figure 3. The length of each station is listed in Table 1.

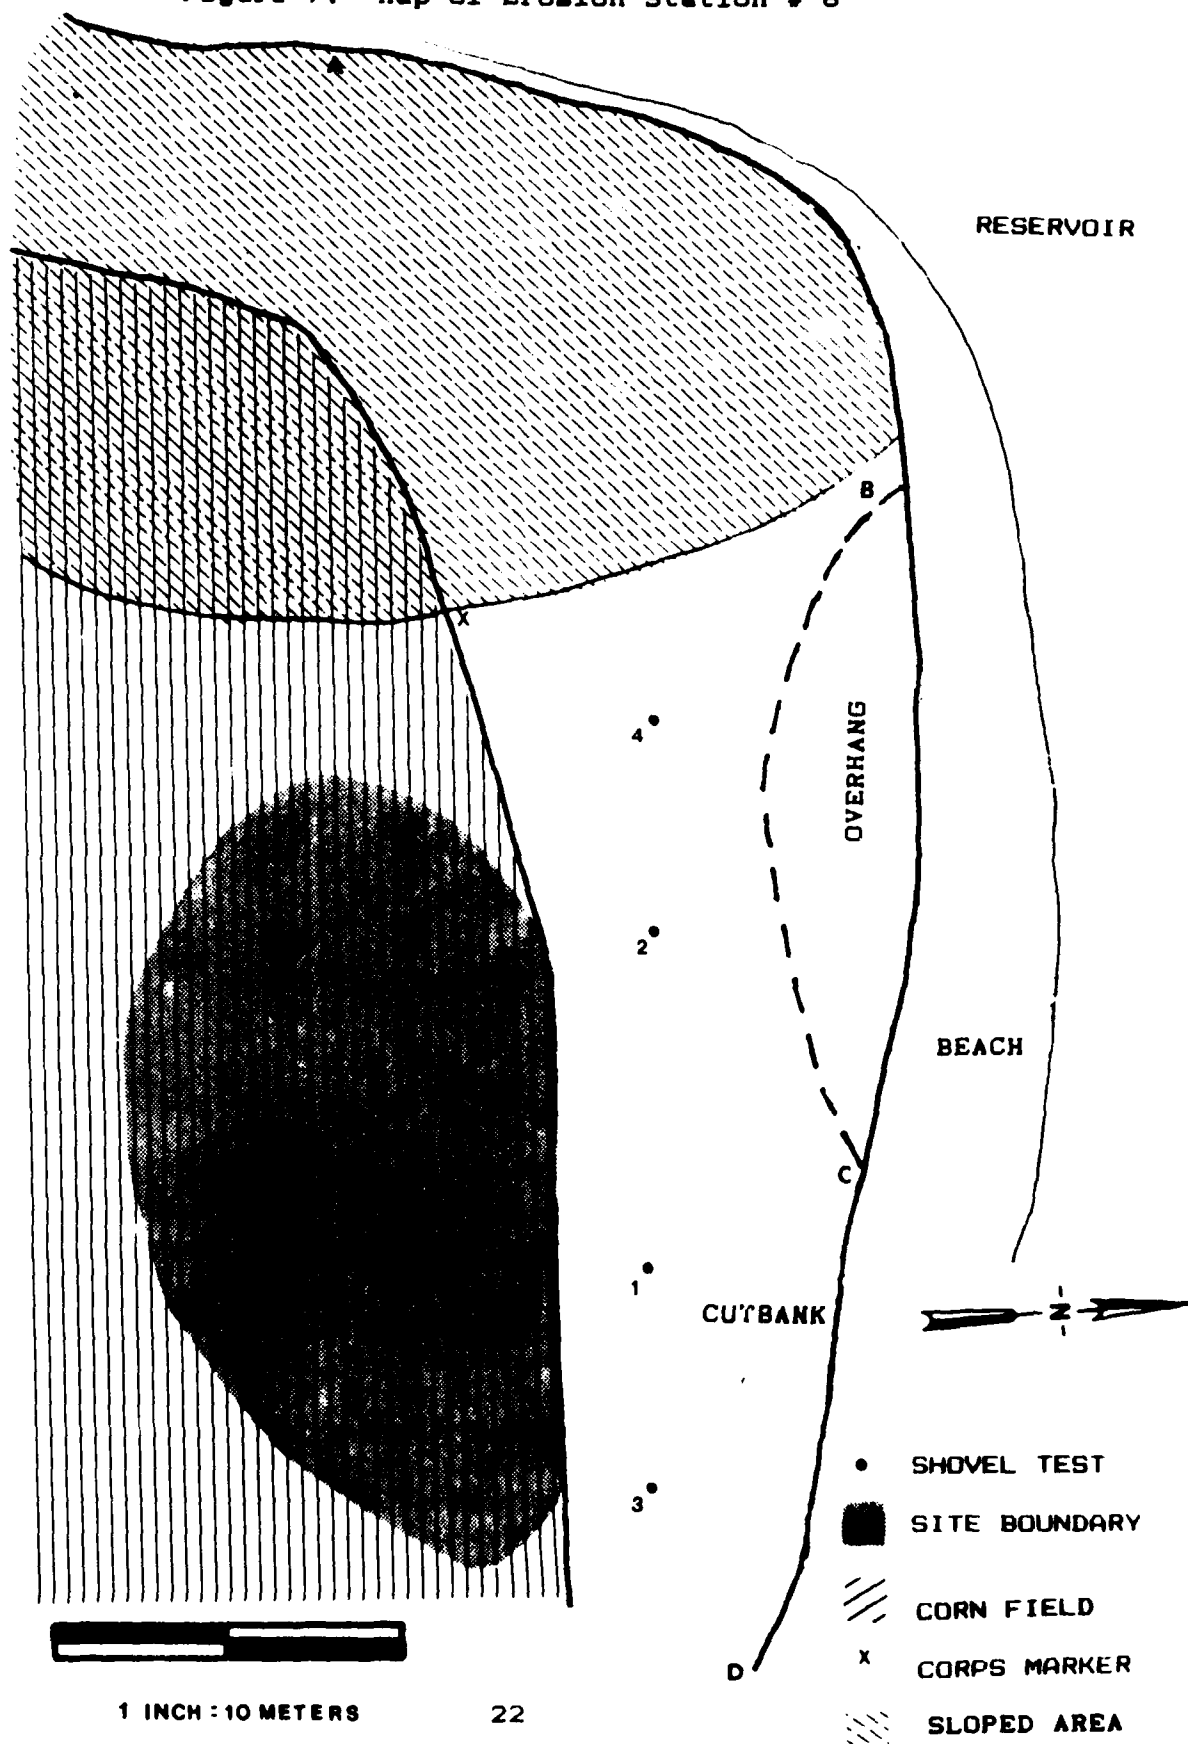
Figure 7: Map of Erosion Station # 6

**Inspection of Beach and Cutbank:** Visual inspection and cutbank planing were done between A and B and between C and D as shown on Figure 7. The entire beach area below the cutbank was surface inspected. No cultural material was found on the shoreline or in the cutbank as a result of planing or visual inspection.

Shovel Test # 3 is situated 10 meters back from the edge of the cutbank and 6 meters from the edge of the cornfield. No cultural material was recovered. Shovel Test # 4 is situated 16 meters back from the edge of the cutbank and 10 meters from the edge of the cornfield. No cultural material was recovered from this pit (See Table 5).

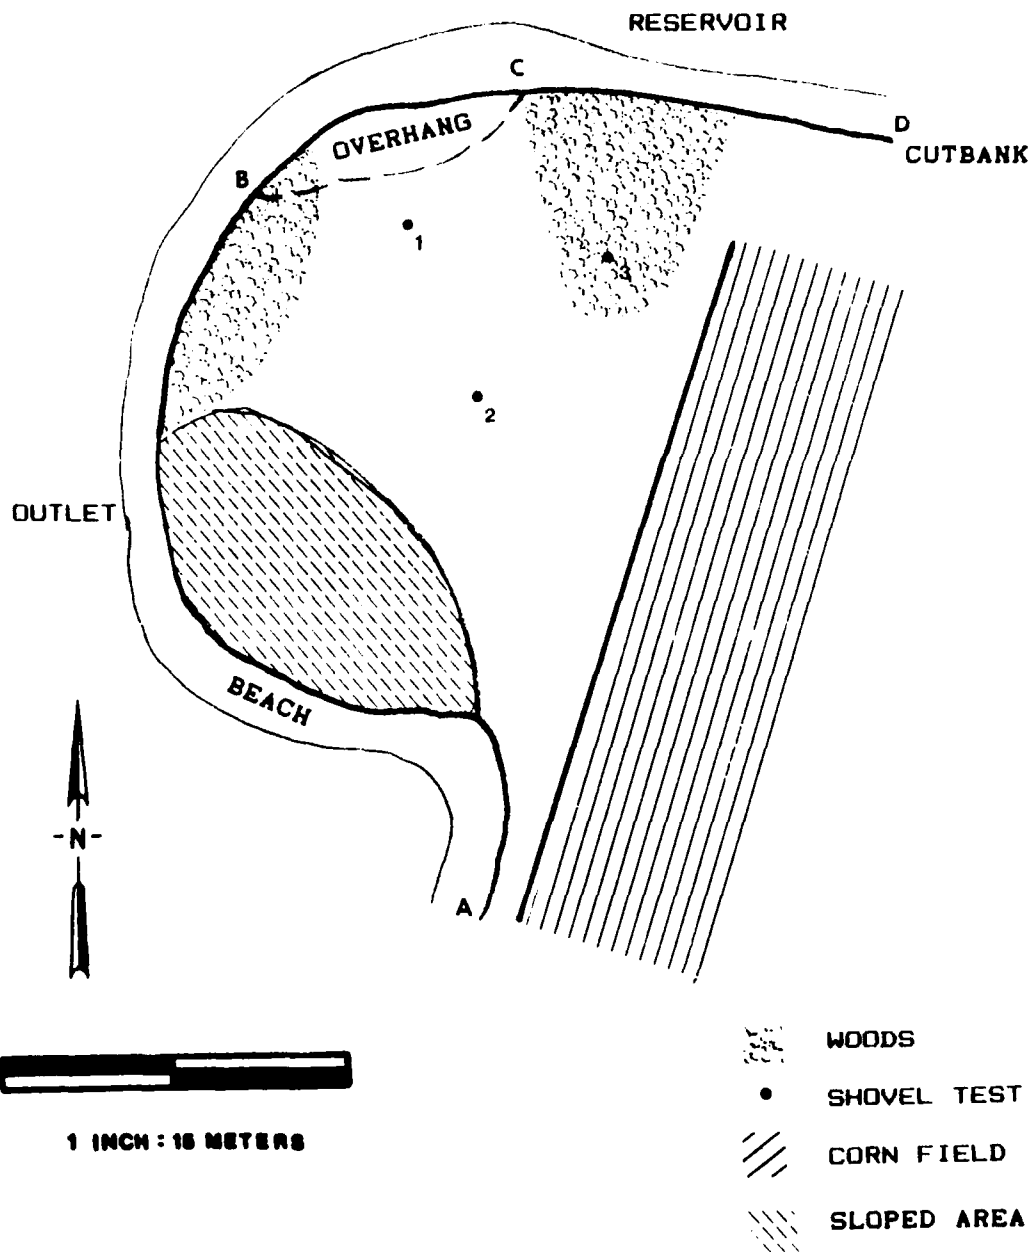
Figure 9: Map of Erosion Station # 7 A

**Inspection of Beach and Cutbank:** Visual inspection and cutbank planing was done at this station from A to B and from C to D. As a result, no cultural material was found on the shoreline or in the cutbank.

Shovel Test # 2 is situated 15 meters south and east of Shovel Test # 1 at the top of the rise. Shovel Test # 3 is situated 15 meters north and east of Shovel Test # 2 in the stand of trees. The topographic variation in this general area prompted a thorough search of the ground surface. Small hand rakes were used to remove the fallen leaves from the surface and subsequent visual examination yielded no cultural material. No cultural material was recovered from any of the shovel tests at this erosion station (See Table 7).

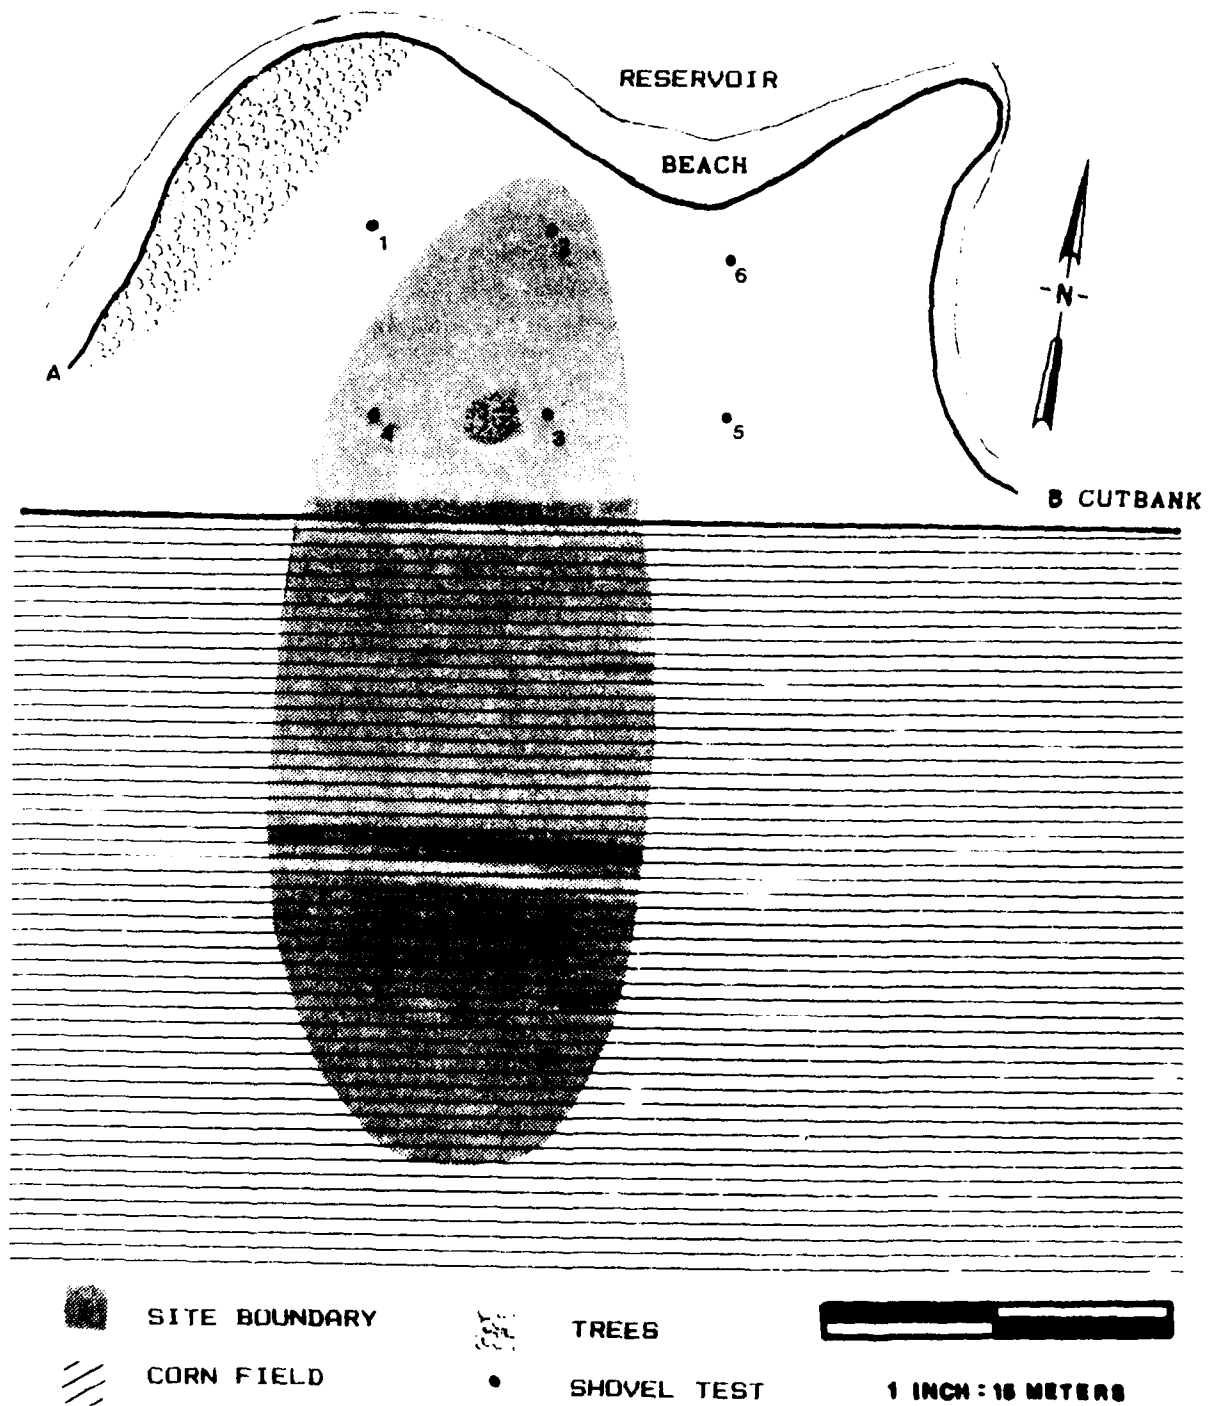
Figure 10: Map of Erosion Station # 8

Inspection of Beach and Cutbank: Visual inspection and cutbank planing was done along the entire bank from A to B. No cultural material was found on the shoreline or in the cutbank.

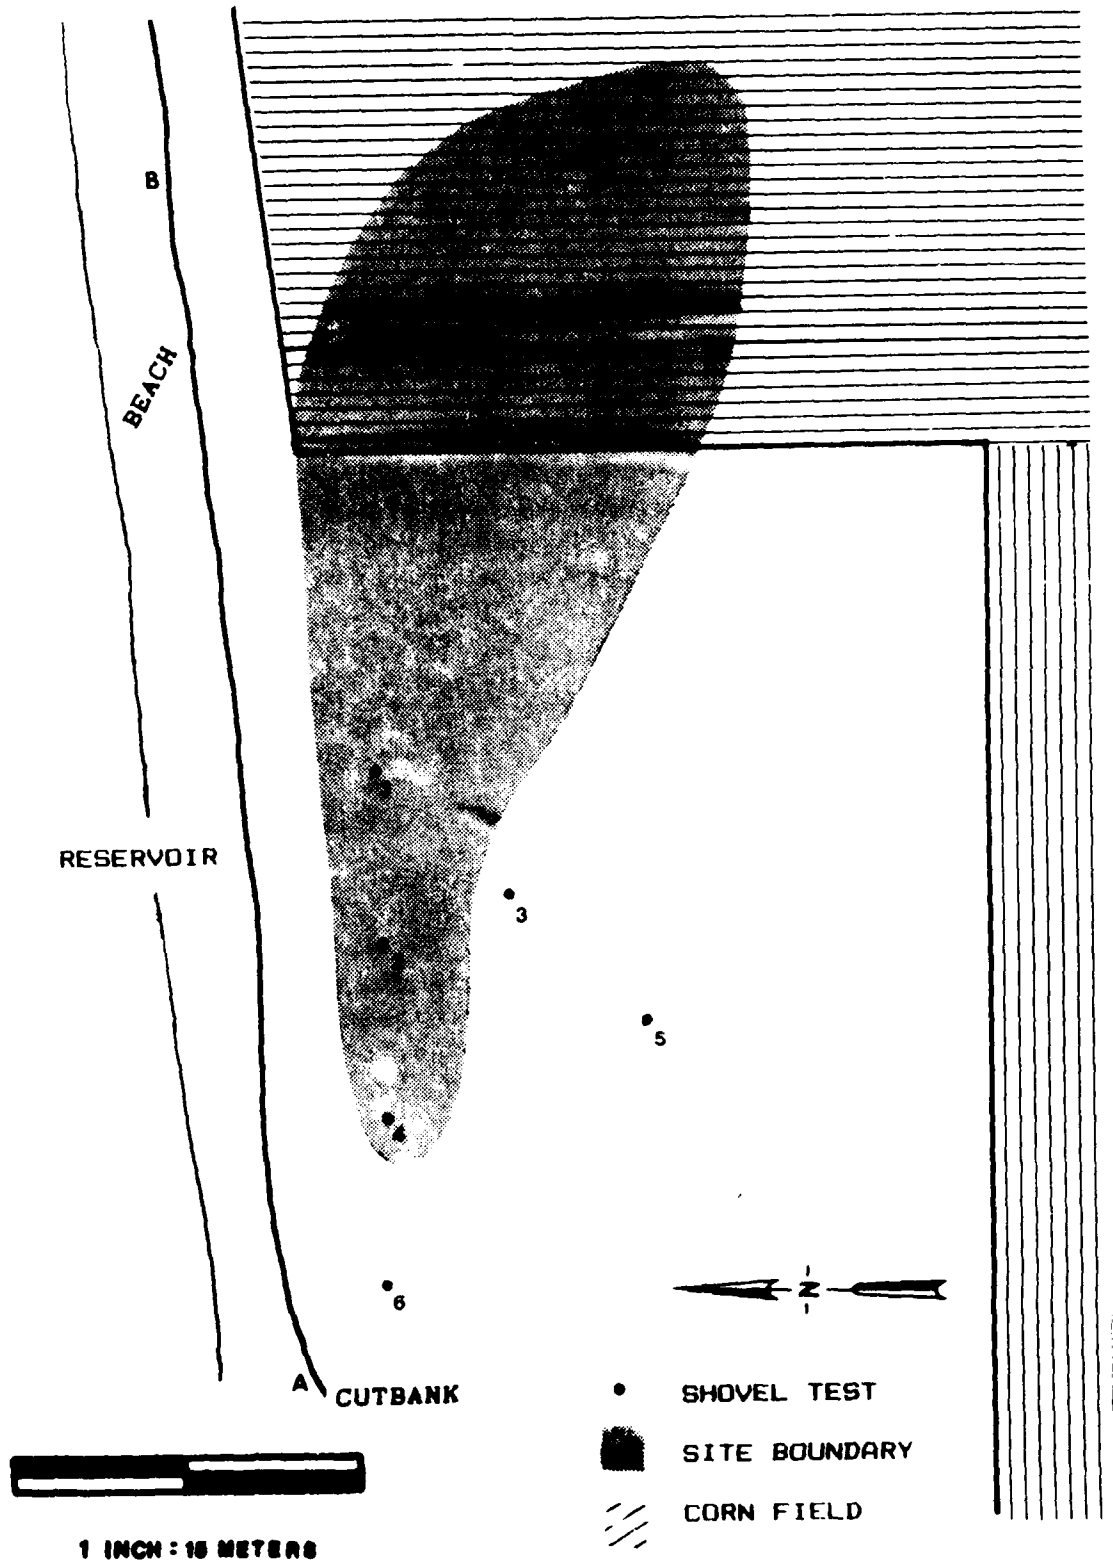
Figure 11: Map of Erosion Station # 8 A

Shovel Test # 5 was placed 15 meters south of Shovel Pit # 3. No cultural material was recovered. Shovel Test # 6 was dug 15 meters west of Shovel Test # 4. The pit was dug to 32 cm. No cultural material was recovered (See Table 9).

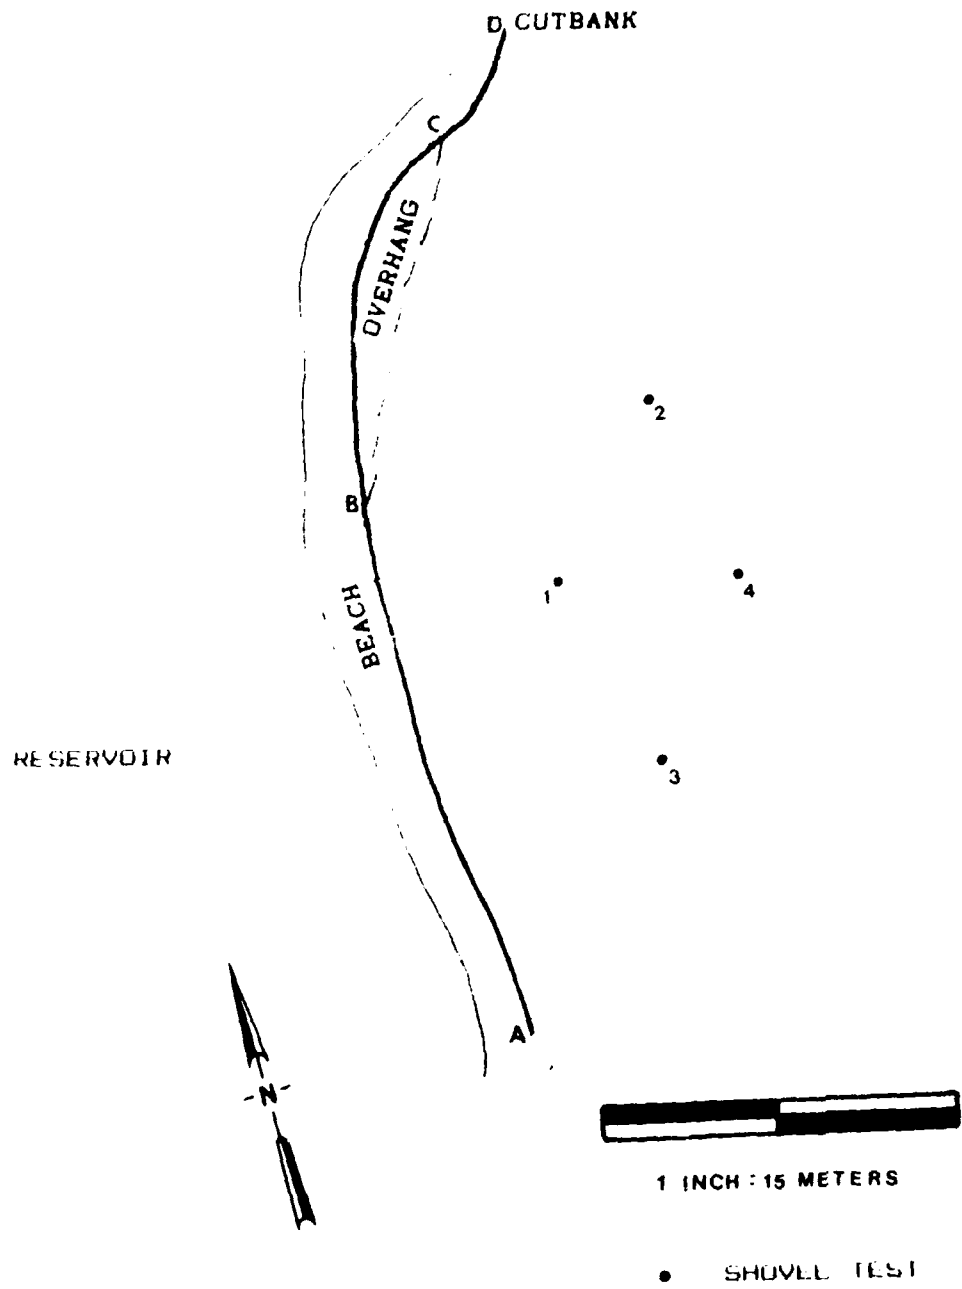
Figure 13: Map of Erosion Station # 10

Shovel Test # 1 was placed 15 meters generally east of the cutbank. Shovel Test # 2 was placed 18 meters north and east of Shovel Test # 1. Shovel Test # 3 was placed 18 meters generally south and east of Shovel Test # 2. Shovel Test # 4 was placed 15 meters east of Shovel Test # 1 (See Table 11).
